Experimental study on the natural vibration characteristics of a steel composite girder bridge before and after reconstruction of the RC slab

Summary

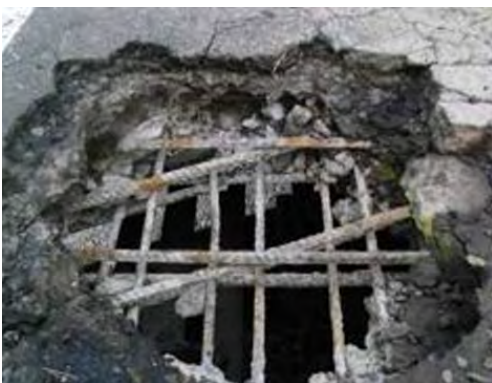
Photo 1: An example of damage to the RC Slabs of bridges

In recent years, deterioration of the reinforced concrete (RC) slab of a bridge tends to be a more severe problem in the case of repeated traffic loads and chloride attack due to de-icing salt in the cold regions of Japan. Photo 1 shows an example of the damage to the concrete of the bridge slab. Occurrences of this kind may rapidly increase in the near future. Usually the deteriorated concrete slabs of bridges were partially repaired and/or whole the slab was completely replaced.
