Strengthening of Riveted Connections of a Steel Arch Bridge: Lessons Learned

Keywords: Steel bridge, tied arch, riveted connections, assessment, strain measurements, load test, design refurbishment, strengthening, fatigue.

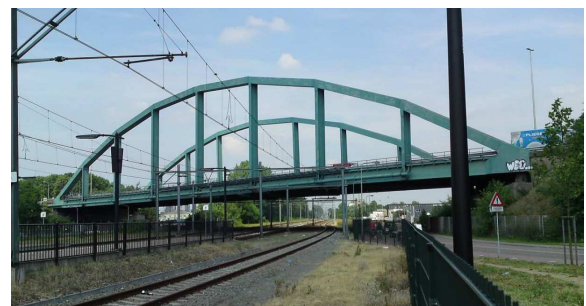
Boogbrug Beek is a steel tied arch bridge which carries the A2 motorway over the Amsterdam to Maastricht railway, see Figure 1.

Figure 1. Boogbrug Beek before renovation
